JOURNAL OF NEPAL HYDROGEOLOGICAL ASSOCIATION (JNHA)

Volume 1

September 2024

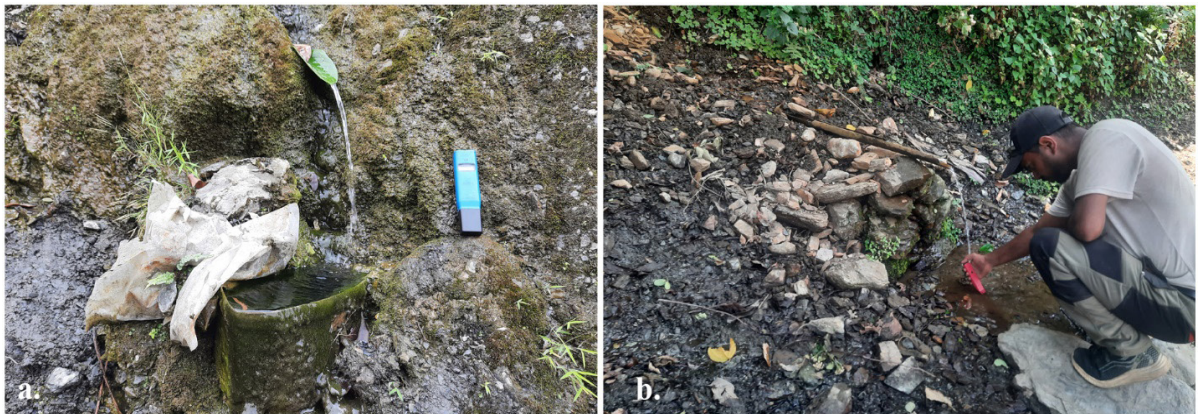
Fig. 2: Photographs of spring sources a) Fault/shear zone spring at Bhimgethi (GPS: 00420437E, 03127705N). b) Measuring the electrical conductivity of spring water at the Huldi/Chhis village (GPS: 00413611E, 03134816N).

Spring inventory was a fundamental part of the research as it provides data on groundwater sources and their distribution (Fig. 2 a and b). The spring sources and their distribution were evaluated from the questionnaire survey. With the cooperation of local people, the spring sources were visited and the source data were collected, recording the information using a designed inventory sheet which includes the name of the spring, an attitude of bedrock (if present), soil types, types of spring, water discharge, land use of a surrounding area, the shifting case of springs and variation in water volume within the last decade. The discharge rate of springs was measured by the volumetric method with the help of a bucket and stopwatch during the field.

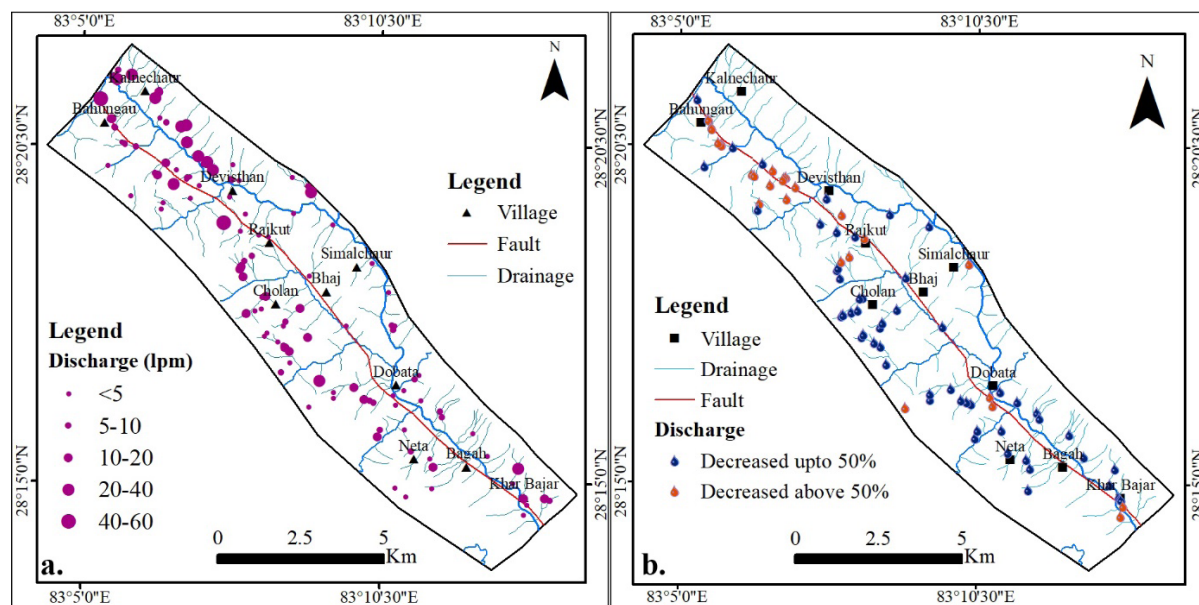
Fig. 6: (a) Distribution of springs by discharge rate. (b) Water volume situation in last ten years.

a result, there are 67 springs of seventh magnitude, 53 springs of sixth magnitude and 1 spring of fifth magnitude (Table 1). Fig. 6a shows the variation of discharge in the study area which ranges from 0.2 lpm to 60 lpm. The discharge of springs on the left bank of Nisi Khola is higher than on the right bank. The landslides and shear zones, frequently observed along the fault line, have a greater effect on the

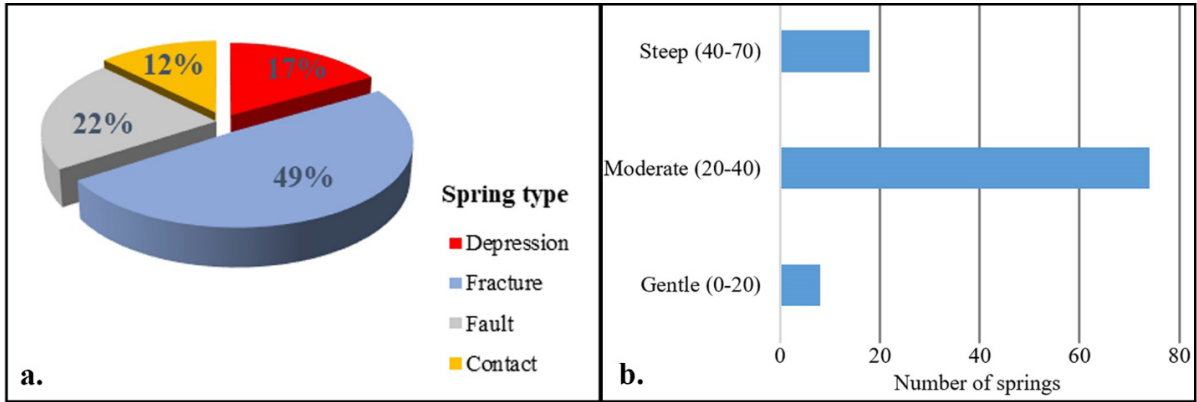
Fig. 7: Distribution of springs based on (a) Spring type (b) Slope.

By inventory of springs, most of the springs are of fracture and fault types, making up 49 % and 22 % respectively; only 12 % are contact springs and 17 % are depression springs (Fig. 7a). But sometimes, a single spring includes two types of spring mechanisms. In terms of slope, 74 % of springs are located on moderate slopes 18 % are on steep slopes and only 8 % are on gentle slopes (Fig. 7b).

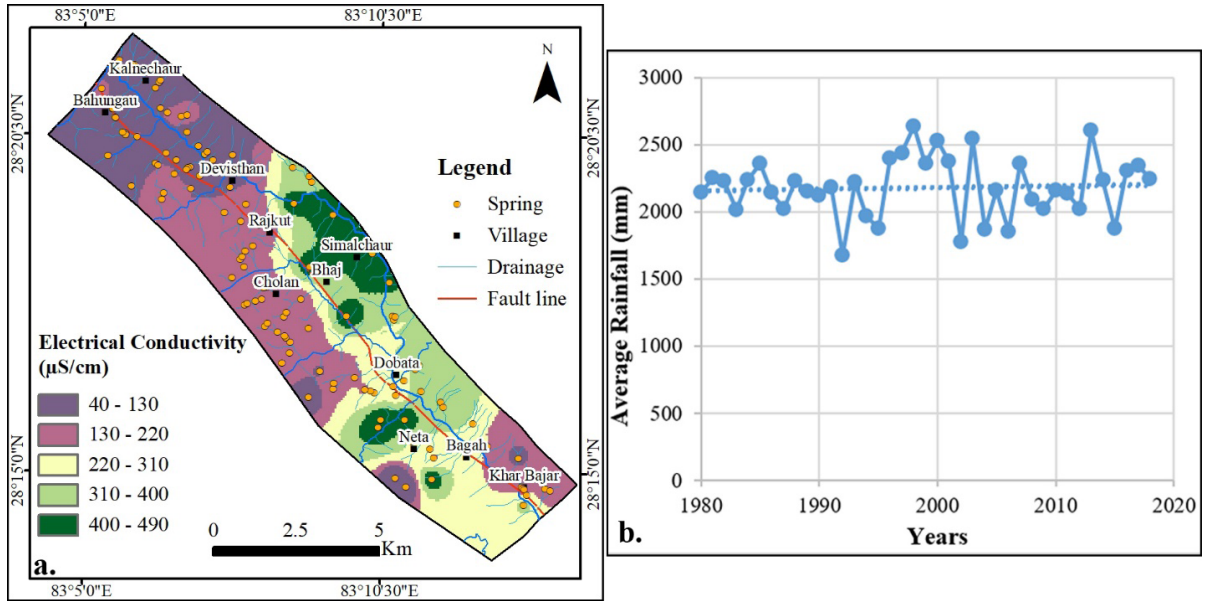
Fig. 9: a) Distribution of electrical conductivity of spring water. b) The average rainfall of the study area (source: Department of the Hydrology and Meteorology, 2022).

Daily precipitation records of three stations were manually checked, compared with surrounding nearby stations, and analyzed to examine the trend of rainfall patterns in the study area over these recent periods. The arithmetic mean method is used to calculate the average annual rainfall of the study area and is found to be 2182 mm. The graph shows a slightly increasing trend of rainfall in the study area (Fig. 9b).

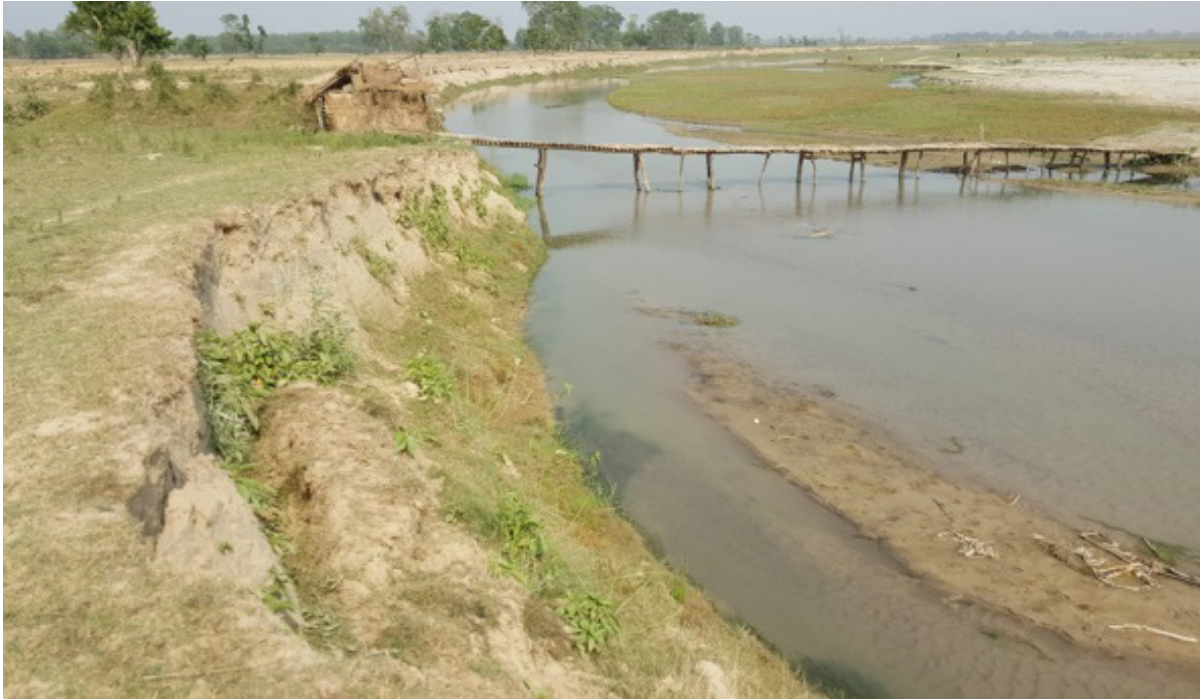
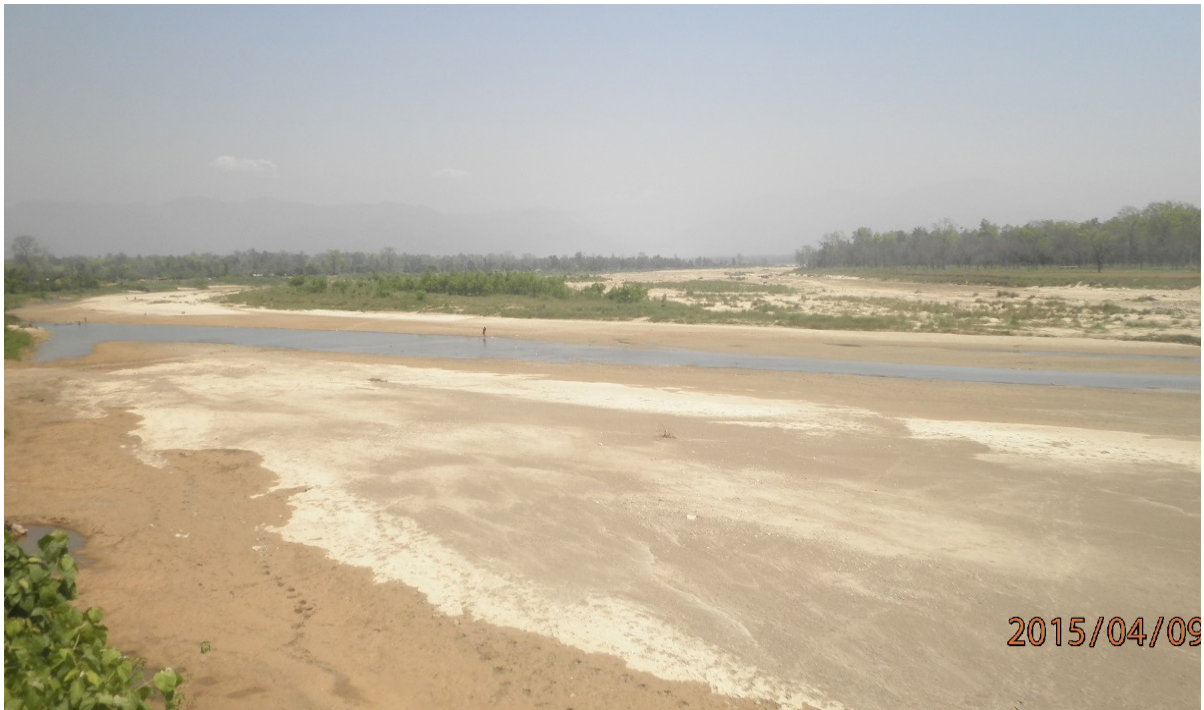
Fig. 8: At 15km downstream from the fan apex. Unlike upstream, the river bed consists mainly of sand, gravel, and silt. Photos on the left show the upstream and right downstream of the Godavari River bridge.

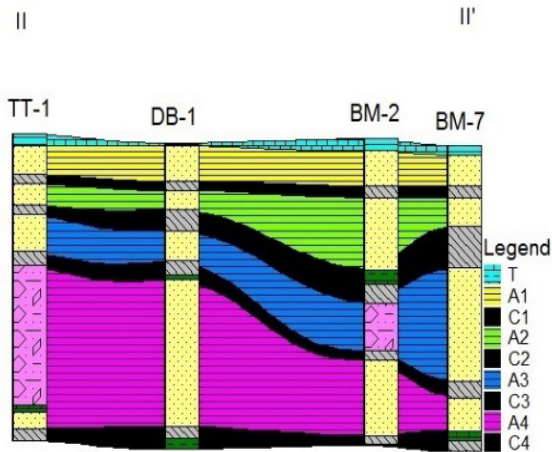
Fig. 15: Hydrostratigraphic units along II-II' profile.

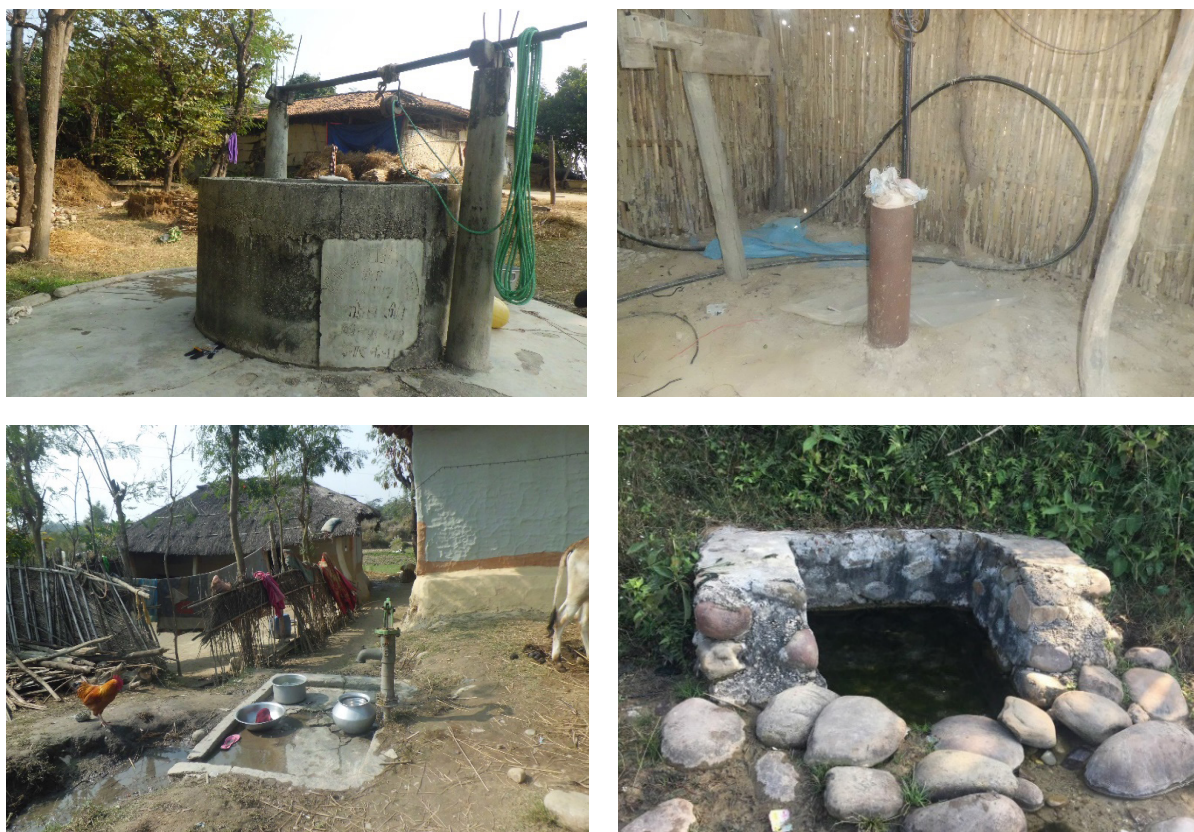
Fig. 4: Some photographs of wells and springs from the Khutti Khola watershed.

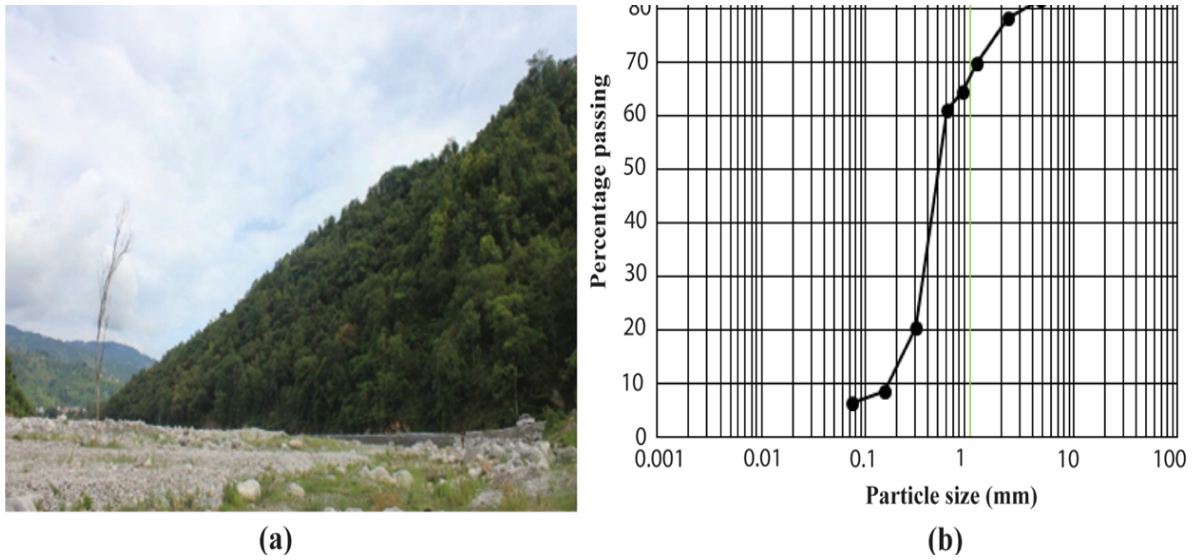
Fig. 6: (a) Flood deposit at the Dolalghat bridge, the southernmost part of the study area, (b) Particle size distribution of sediment sample collected at the Dolalghat bridge site.

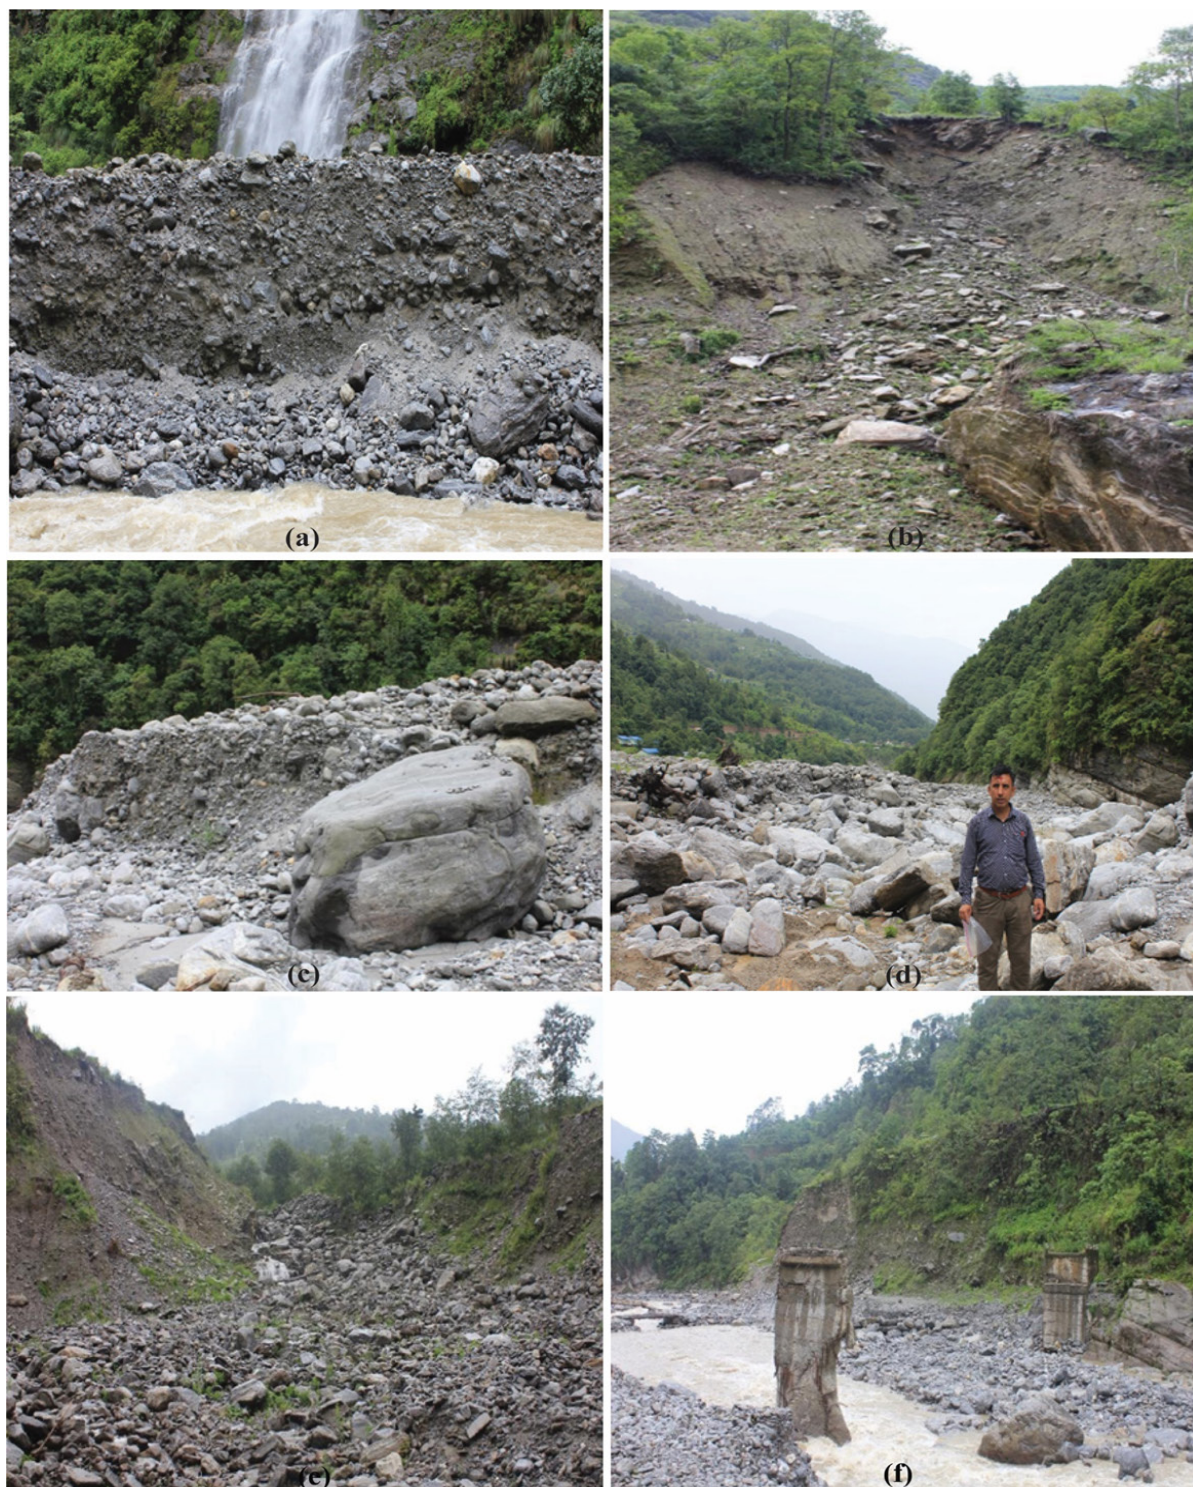
Fig. 7: Debris flow, landslide and flood related observations between the headworks and Ambanthan, (a) Deposits seen at the road section, (b) Landslide of colluvial soil on weathered gneiss, (c) Debris flow cliff (4m), (d) Debris flow remanent at Timbu, (e) Cut height of debris at the bank of tributary, (f) Ambathan road washed out bridge.

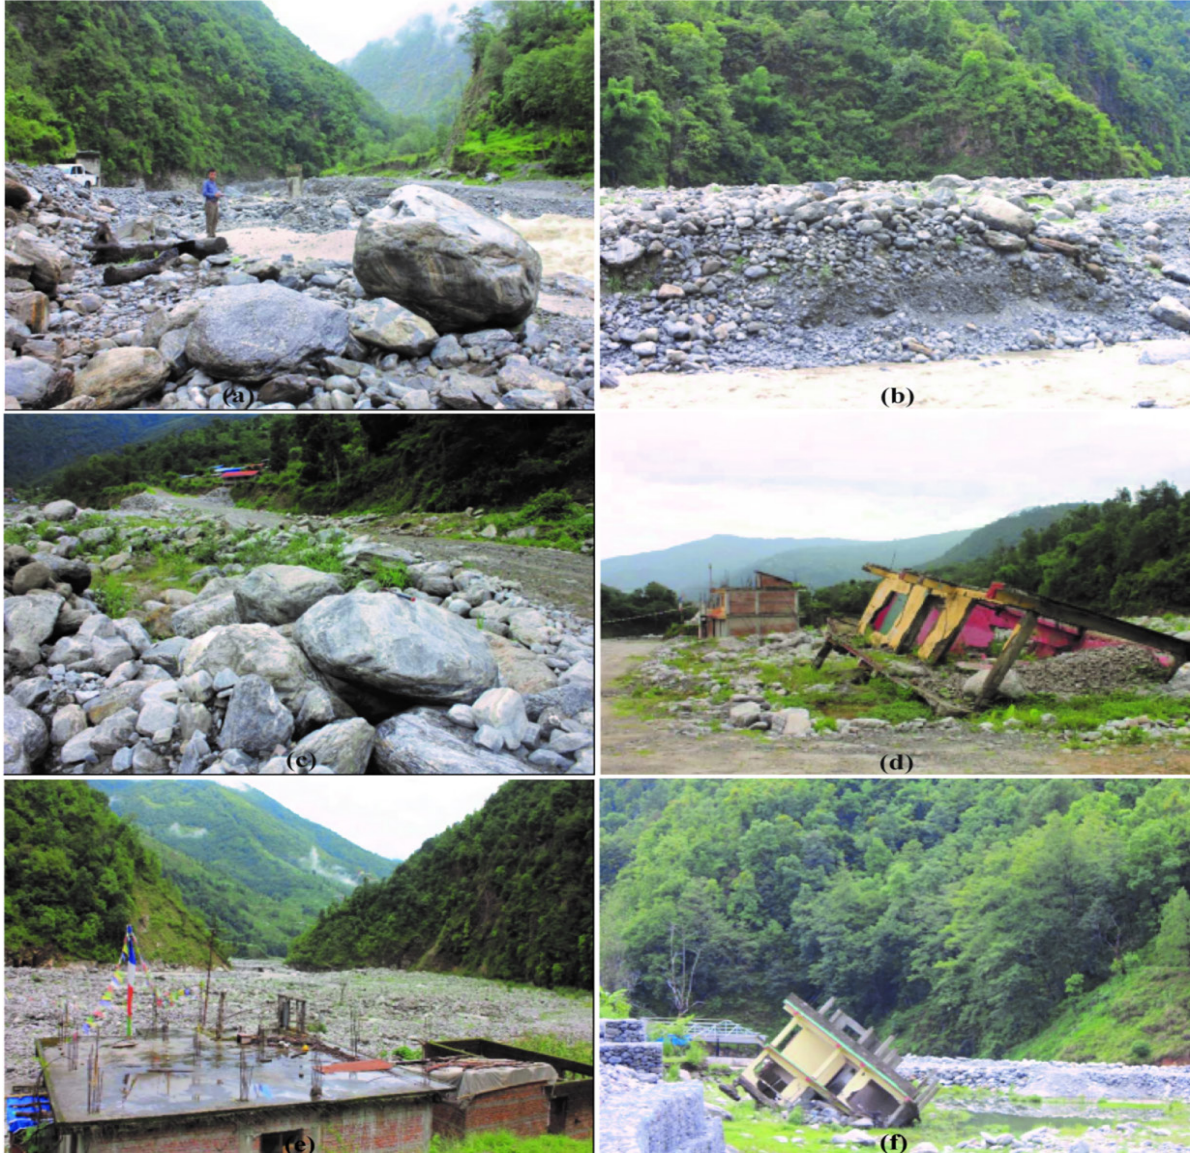
Fig. 8: Debris flow, houses damaged and buried between Ambathan and Ganeshi (a) Boulder of the flood erosion at Ambathan, (b) Inverse grading of the debris flow deposits south of Halde, (c) Road on the boulder bar at Kiul, (d) Destroyed houses at Ganeshi, (e) Houses partially buried by debris flow at Halde, (f) Damaged house at Kiul.

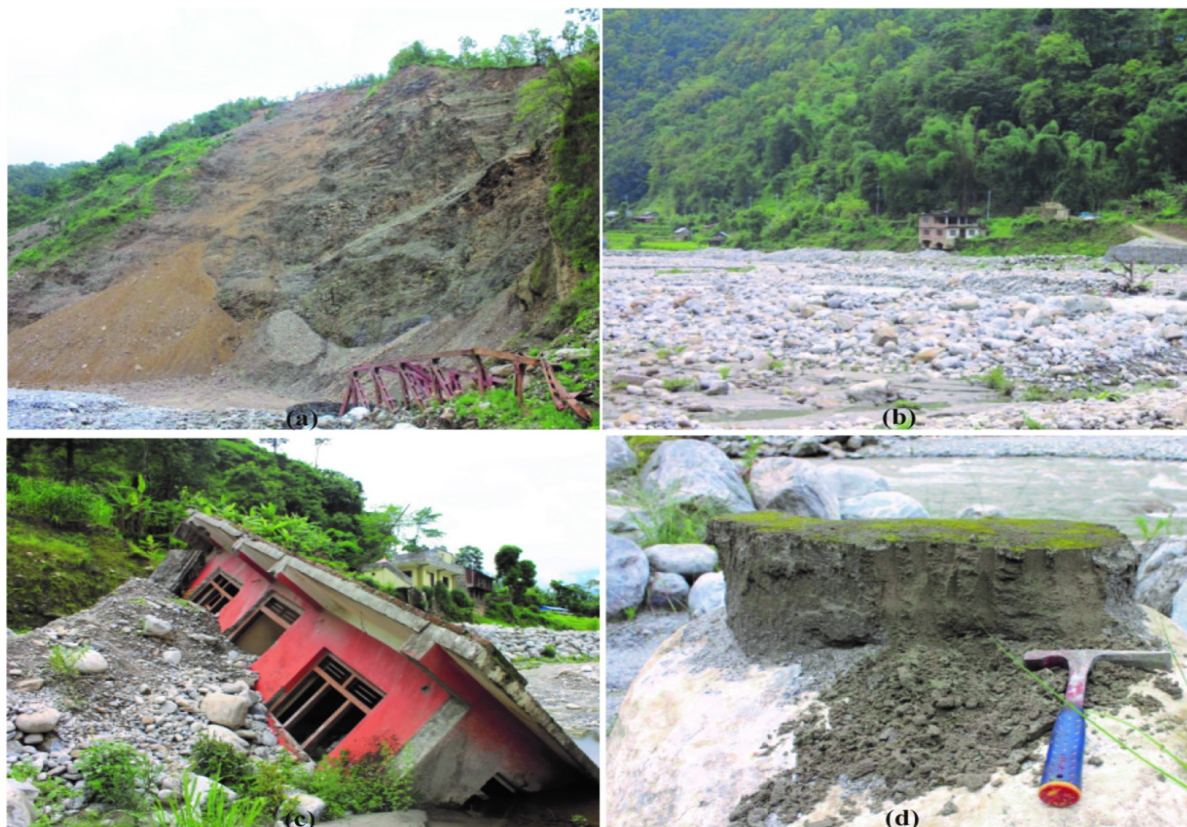
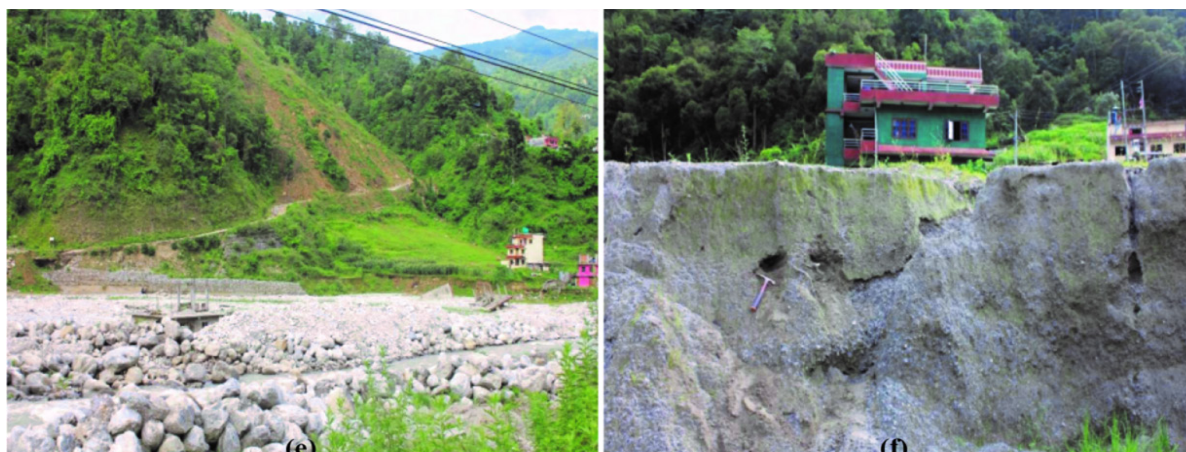
Fig. 9: Damaged bridge, houses, sand bar observed between Gyalthum and Danuwar gaun. (a) landslide opposite Gyalthum with baily bridge, (b) Melamchi khola bar SW of Gylthum, (c) Collapsed building at left bank of Melamchi river at Thulokhet, (d) Sand bar on top of boulder, (e) Destroyed building of Danuwar Gaun (f) Fine particles deposietd on 3m high bar near damaged bridge abutment.

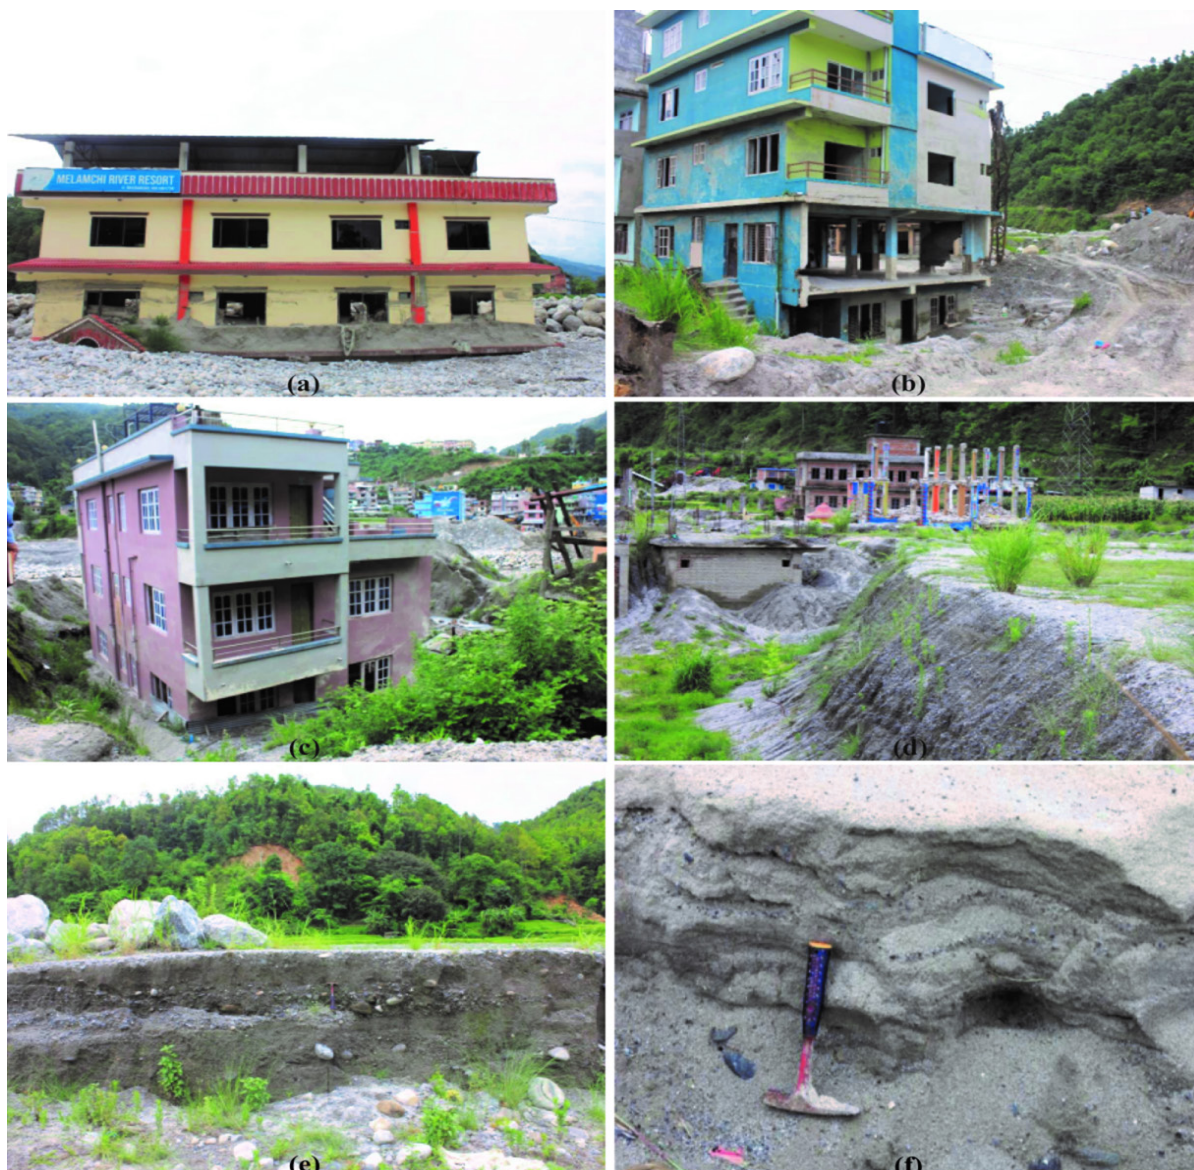
Fig. 10: Buried houses, flood mark, debris flow deposits, sand bar observed below Danuwar gaun and Dolalghat. (a) Buried Melamchi river resort, (b) High flood mark on green blue buildings, (c) Houses buried on two floors on Melamchi bazaar, (d) Debris flow deposits at the transverse from Melamchi to Dolalghat area, (e) Deposits of Crudely stratified sand bed at Bahunepati, (f) 30 cm thick sand bar near Sipaghat at Eklebesi, Magitar
